Structural and Corrosion Performance of Continuous Galvanized Rebar (CGR)

Anil Patnaik, PhD
Professor and Associate Chair
Department of Civil Engineering
The University of Akron
Akron, OH 44325

Report Submitted to:

GalvaBar
5101 Bird Creek Avenue
Port of Catoosa, OK 74015
January 2019

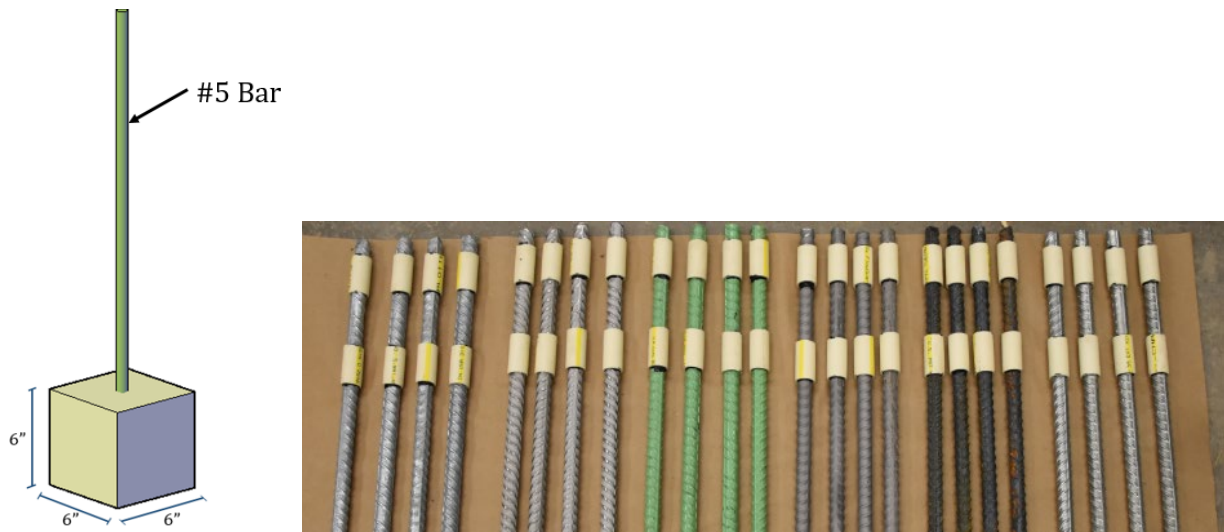
Figure 3 Pullout Specimen Details (Left) and Bar Types (Right)

Of the 48 specimens mentioned in Table 3, a total of 24 specimens were subjected to accelerated corrosion for a period of 10 days. Five percent corrosion level was used as a basis and the current intensity was calculated using Faraday's equation. An impressed current of 0.02 A was applied to the bars; a specially made casing using stainless steel plates was used as the cathode. A 5% NaCl solution was used as electrolyte in a plastic tank, in which the specimens were immersed until the solution just reached the top surface. A two-day wetting and one day drying cycle was used to increase the effect of corrosion. A typical test setup for the corrosion process is shown in Figure 4. Both corroded and non-corroded specimens were tested for pullout strength using a Baldwin universal testing machine with a capacity of 300 kips.

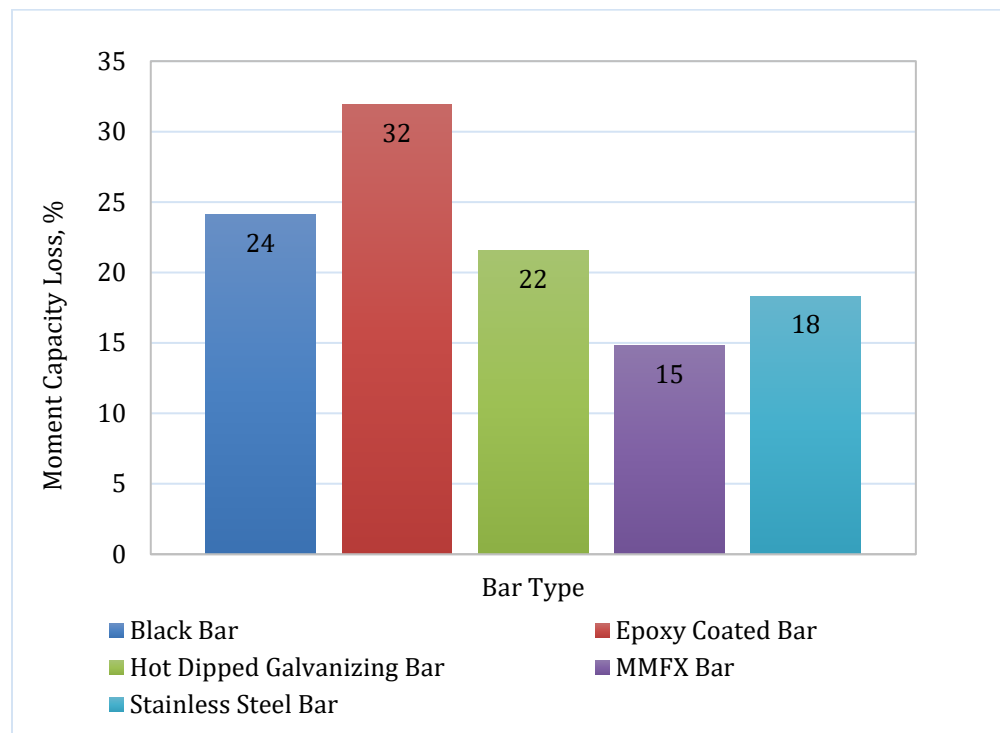
Figure 12 Flexural Capacity Loss Due to Corrosion of Specimens with no Fiber

Figures 12 and 13 present charts showing the flexural capacity test results of slabs with no fiber and with fiber, respectively. As can be seen in Figure 12, epoxy-coated bars with 5% damage induced on the coating showed the largest extent of corrosion compared to the other bar types, in terms of maximum flexural capacity loss due to loss in bond and reduced area of steel. MMFX bars showed the best corrosion resistance and the lowest loss of pull-out strength. In hot-dip galvanized bars, the zinc coating protected the bar from corrosion for a few days; once the sacrificial layer was compromised, the base metal showed a similar effect as the black bars. Hence, the capacity loss for the slab with hot-dip galvanized bars is much closer to that of slabs with black bars. Slabs with stainless steel bars also showed good performance after corrosion as well as a smaller loss of flexural capacity due to corrosion.

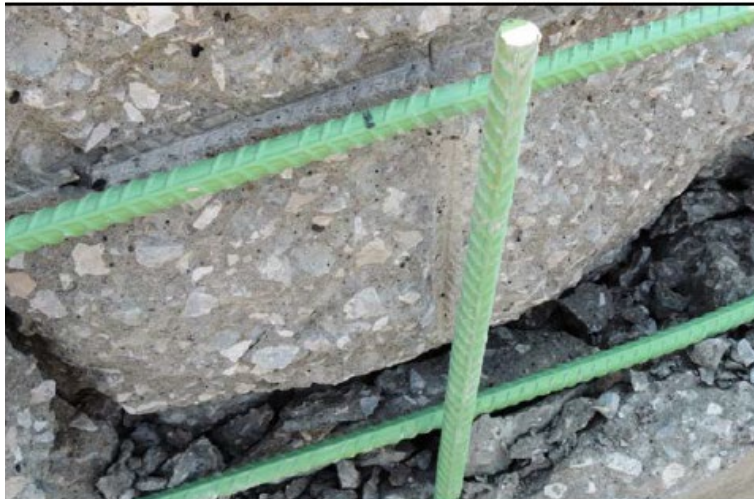
Figure 30 Lack of Bond Between Epoxy-Coated Bars and Concrete Under Impact Loading¹¹

30 shows the crumbling of the concrete surrounding an epoxy-coated bar under impact loading. This type of deficiency is more serious for larger thicknesses of epoxy coating. Dual-coated reinforcing bars are also similarly disadvantaged.

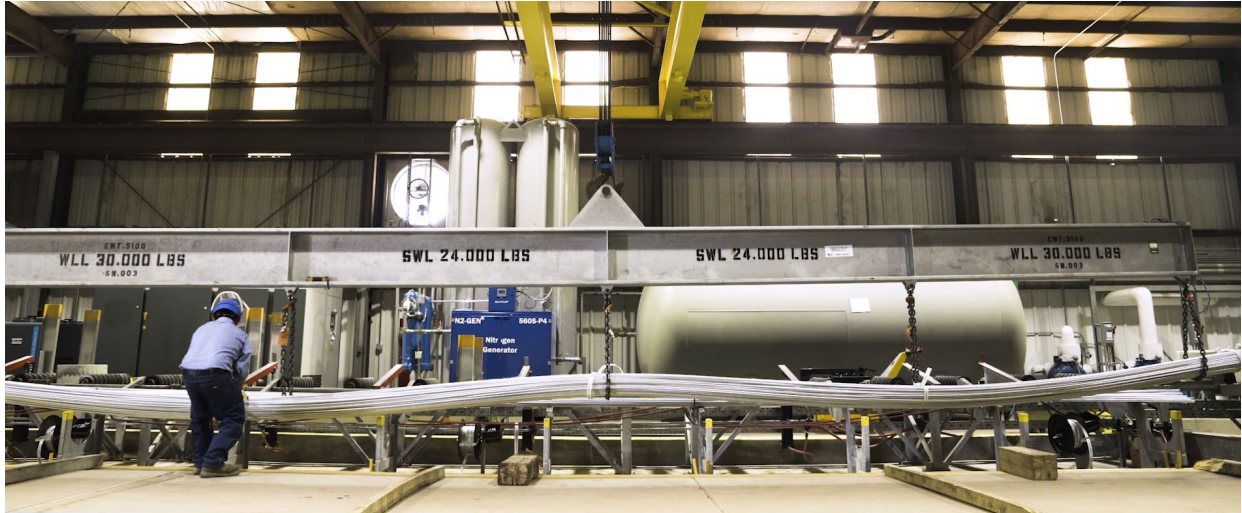
Figure 31 GalvaBar Production Facility in Oklahoma, USA⁷

In the United States, a plant in Oklahoma produces GalvaBar™ using a continuous galvanizing process. This plant (Figure 31) uses a highly automated, proprietary process to produce CGR at significant cost efficiencies, including lower material and labor costs. The GalvaBar production process at this plant can be applied to many grades of steel, providing a consistent coating with no risk of embrittlement. GalvaBar complies with the requirements of ASTM A1094/1094M-16 for continuous hot-dip galvanized steel bars and concrete reinforcement. Further details of GalvaBar are available on the CMC website.⁶

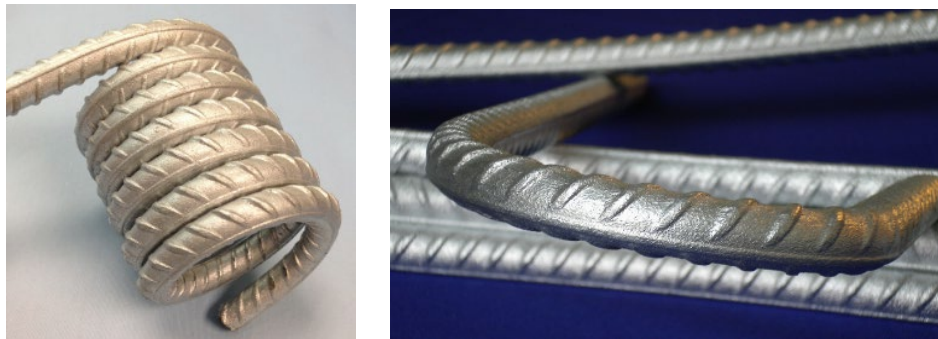
Figure 32 Bendability of GalvaBar

GalvaBar is a galvanized rebar with specialized thin zinc alloy coating that provides the well-known corrosion protection of zinc and the added benefit of exceptional formability. GalvaBar can be bent, twisted, or stretched after galvanizing without cracking, peeling or flaking. Two examples of CGR bends are shown in Figure 32. The material specifications, frequently asked questions and the guidelines for construction practices for GalvaBar (as posted on the CMC website⁷) are included in the appendix at the end of this report.

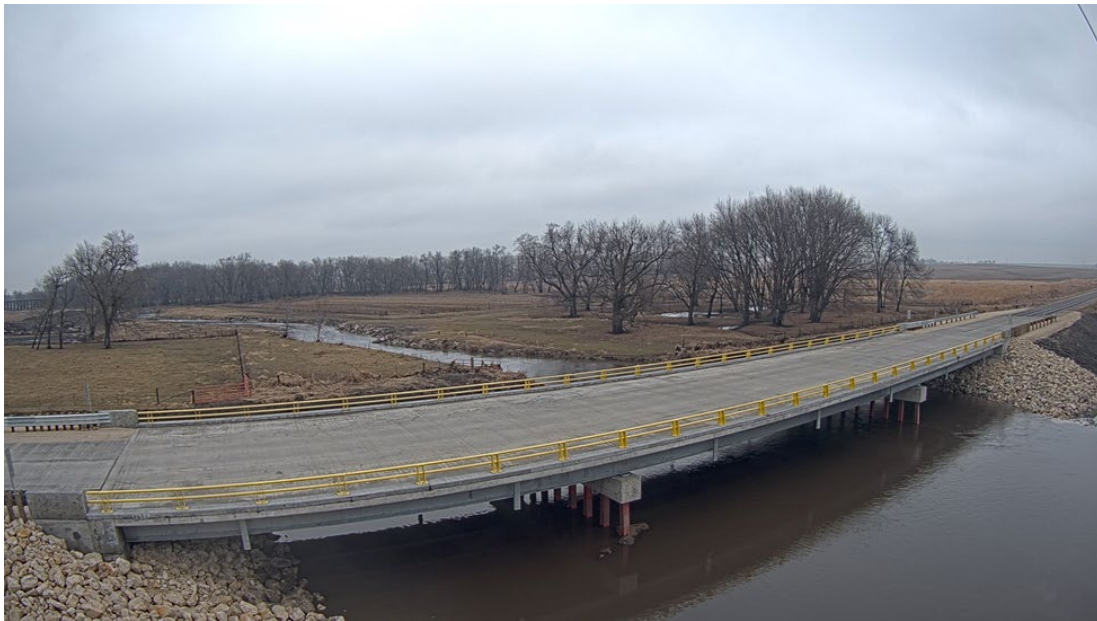
GalvaBar has been used in a project in Iowa for the Buffalo Creek Bridge in Independence, Iowa, with a 200' deck (Figure 33). The abutments and parapets utilized continuous galvanized GalvaBar. GalvaBar was also supplied for the Coffee Creek Wastewater Treatment Plant in Edmund, Oklahoma. GalvaBar is being used for many balconies, seawalls and foundation projects in Florida. GalvaBar has been shipped as far as Bahamas and can also be purchased from Menards home improvement centers.

Figure 33 Buffalo Creek Bridge in Independence, Iowa
GalvaBar was used in the Abutments and Parapets of this Bridge
